# CASE STUDY

## Application-specific design and proven customer service in seawater service

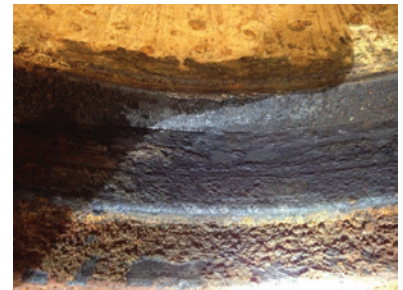
*Material loss in the seat pocket was caused by galvanic corrosion, allowing leakage around the valve seats.*

Ultimately, the solution came from industry and field knowledge, valve expertise, insanely customer-centric service and innovative valve designs. MOGAS design standards are ideal for corrosive environments, and has experience with seawater applications. Replacement valves were provided with a nickel-based super alloy inlays on all sealing surfaces and through the bore. These valves also used a metal-seated ball valve (not soft seating), supported by a live-loaded disc spring to maintain a tight seal. All external components were painted with an improved paint specification above industry standards to insulate from the salty humidity.

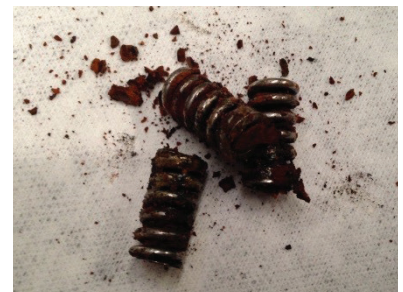
*Fine silt packed the coiled spring pockets preventing free motion and an effective seal.*
