# CASE STUDY

## High pressure and erosion jeopardize safety and profits in water cutting application

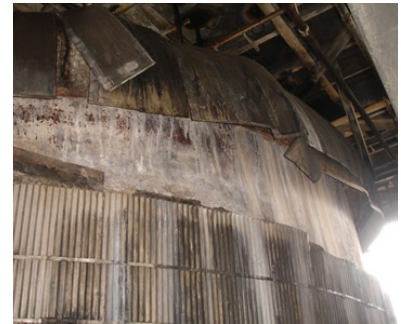
When in the closed position to isolate, the valve—a competitor's 6-inch, ASME 2500 Class valve originally sold as part of the pump package—leaked large amounts of water through the valve's packing onto coke drums, causing the drum to bulge and deform. This, coupled with the country's high humidity, caused the thermal insulation on the coke drum to fail. Coker drums reach 925° F (496° C), and the heat from the uninsulated drum was suffocating to plant employees. The leaking water also produced an unsafe environment on the upper deck, and dripped on to instrumentation and wiring on the lower deck creating a safety hazard.

*Leaking water from a competitor's valve caused damage to the coke drum's thermal insulation.*

In early 2016 the plant replaced the leaking valves with MOGAS 6-inch, ASME 2500 Class, model CST-1 valves. This industry-proven valve is engineered specifically to perform in slurry and high erosion applications, and features:

- a tracking seat design for true bi-directional shutoff that prevents slurry build-up behind downstream seat
- leak-free Grayfoil packing and a pressure-energized stem seal that prevents solids accessing stuffing box
- HVOF chrome carbide-coated seats prevent erosion
- Belleville springs that maintain correct seat position for absolute sealing
- Mate-lapped ball and seats with wider sealing surface for absolute shut-off
