A large Canadian energy producer faced frequent switching valve failures in their coking operation that led to premature shutdowns. After additional valve fixes failed to deliver extended operational intervals, they turned to MOGAS.

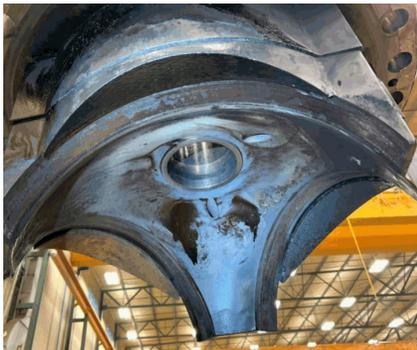
The bonnet and end connects showed remarkably small amounts of coke build-up.

A planned shutdown took place after one year and the MOGAS DV-4 valve was disassembled for internal inspection. There was no coke buildup inside the valve body. The valve's performance did not result in any unexpected shutdowns and it withstood unit upsets that would have otherwise damaged the competitor's valve. The valve's bonnet design and nonuse of bellows effectively prevented coke from accumulating on the ball—a critical factor in the previous setup—even without the use of a purge drain. The absence of coke buildup was a welcoming outcome for the client, further demonstrating the valve's exceptional performance.

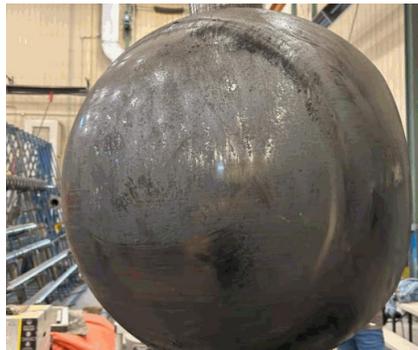
Down stream side of ball after being removed in the MOGAS service shop.
